Affected models: 8960-1x - Prime Mover / Dynamometer

Speed output signal inaccuracy at low speeds.

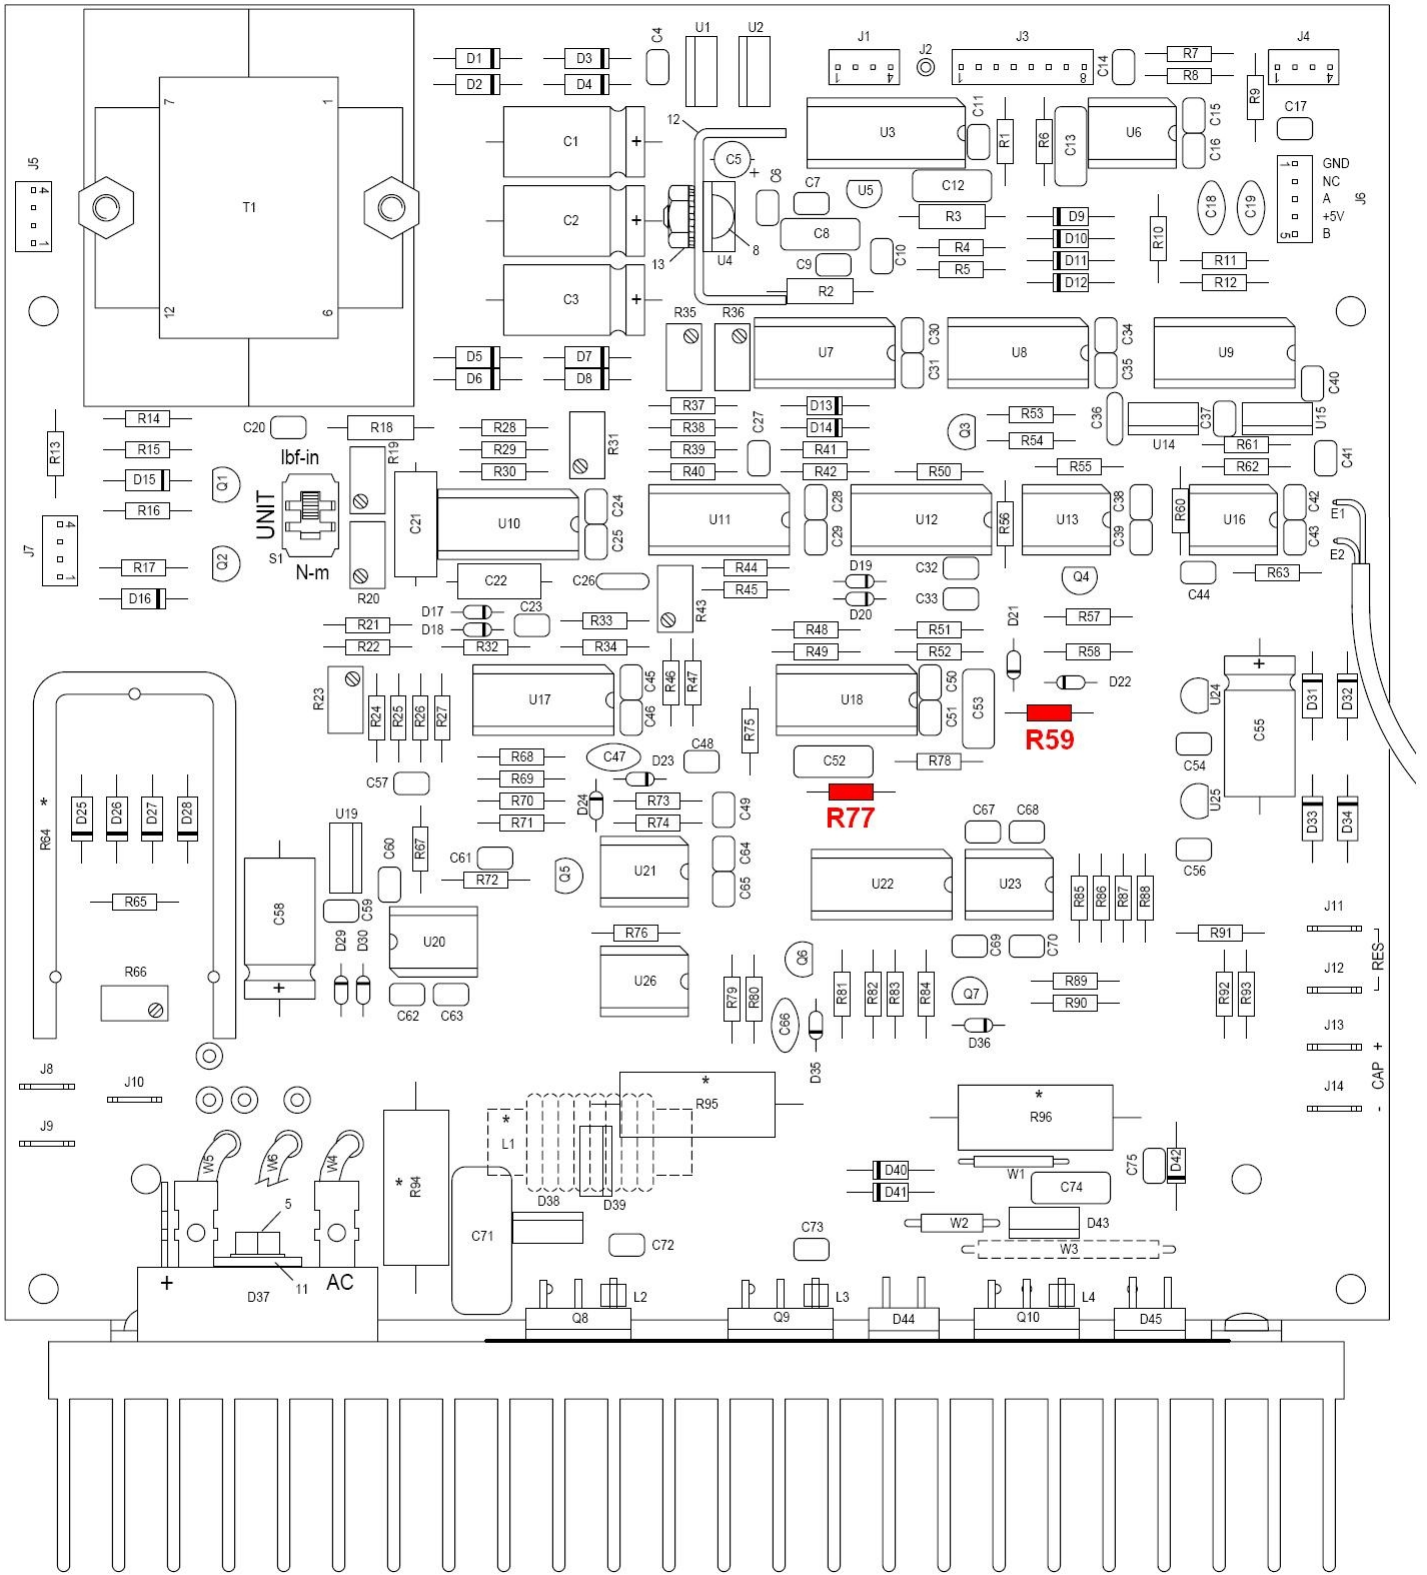
When the 8960-1x is running counterclockwise at speeds between 0 and 600 rpm, the speed output signal does not vary accordingly to the nominal rate of 500 rpm / V.

To fix this problem, two resistors (R59 and R77) have to be replaced on the printed circuit board (30350 rev. 2) which is located beneath the motor. To know the new value of these resistors and where they are located on the printed circuit board, consult the table and figure below.

Identification	current resistor value	New resistor value
R59	1.0M Ω 1/4W 5%	22.0M Ω 1/4W 5%
R77	10.0k Ω 1/4W 5%	2.4k Ω 1/4W 5%

This product fix is valid only for 8960-1x units that have the revision #2 of printed circuit board 30350. Before you undertake this modification, look at the upper left corner of the printed circuit board (beside Transformer T1) to make sure that your 8960 1x has the a revision. In the event that your 8960-1x has an older revision of printed circuit board 30350, contact us by Email at: services@labvolt.com.
