Lab-Volt® 0.2-kW Electromechanical Training Systems(98-8001) Product Fix: Synchronizing Module 8621-0x pilot lamps problem

Release Date: 2010-07-02

Affected Models: 8621-0x, Synchronizing Module

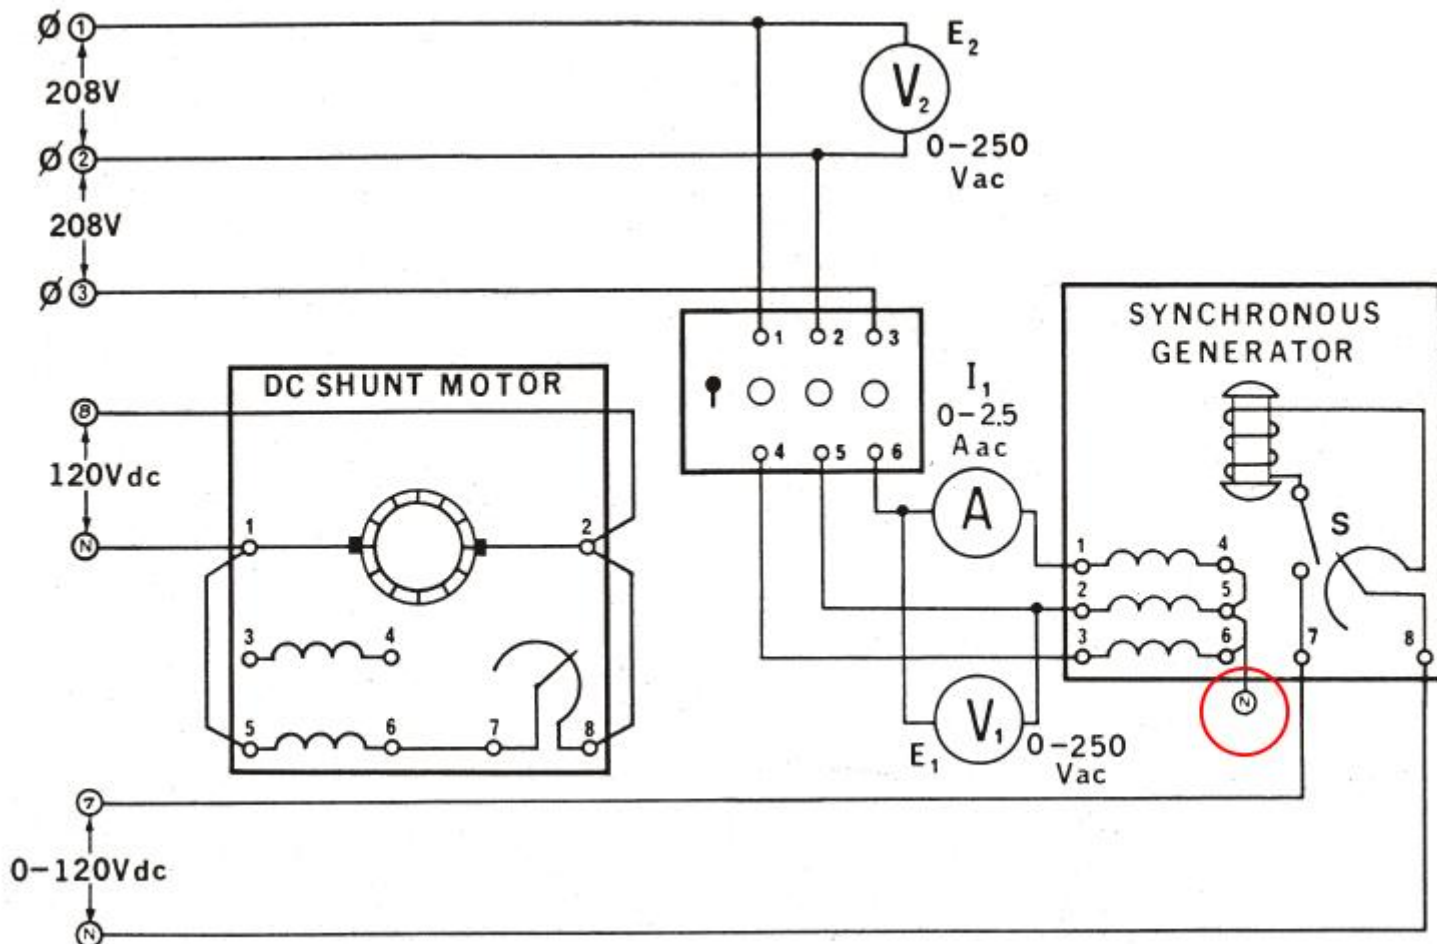
The pilot lamps of the Synchronizing Module do not light when the unit is used to synchronize an alternator to the power network.

This problem is caused by diodes which are in series with the pilot lamps in the new versions of the Synchronizing Module, and also because the neutral connection of the alternator is missing in some exercises.

The neutral point of the alternator must be connected to the neutral terminal of the Power Supply as shown in the following figure.
